Town of Lincoln, MA Landfill
Solar Site Assessment and Habitat Evaluation

June 7, 2016

Prepared by:
Rimmer Environmental Consulting, LLC
57 Boston Road
Newbury, MA 01951
www.rimmerenv.com

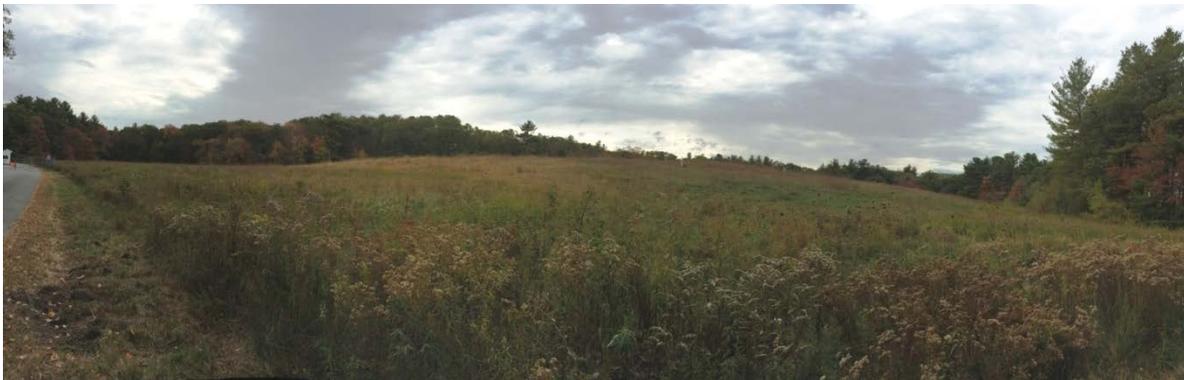
Photo 1: View southeast from access drive, October 2015

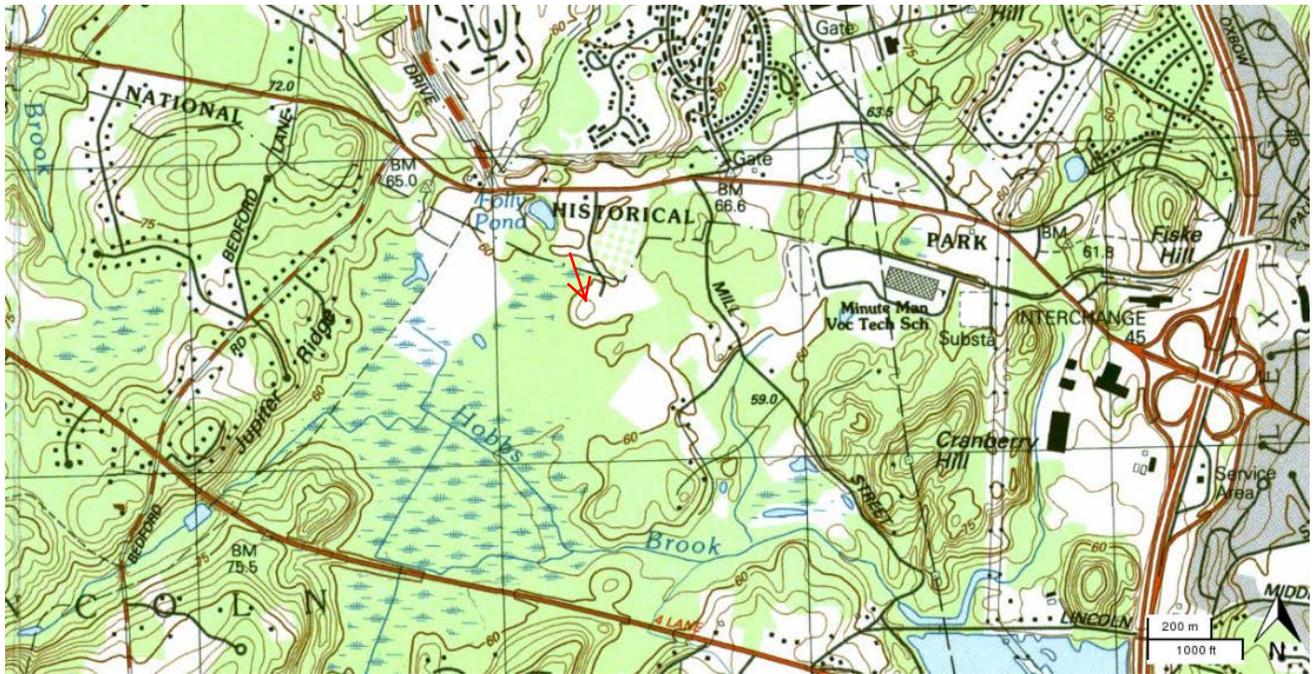
The site consists of an oblong mound running east to west. It rises gently in elevation approximately 30 feet from Mill Street to the top of the capped landfill then slopes steeply back down to the wetlands on the west and south sides with more gradual slopes extending toward the forested land to the east. The site drains from the top of the cap in all directions. Drainage from this site contributes to the Cambridge Reservoir watershed.

Figure 2: USGS Topographic Quadrangle

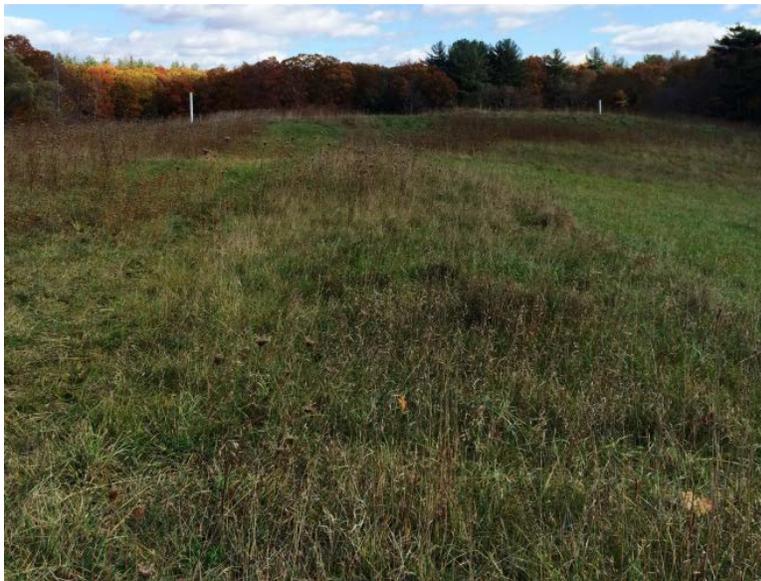
1. Upland Grassland: This is the dominant vegetative community, encompassing 5.27 acres on the upper slopes of the landfill site. It is dominated by three non-native species: sheep fescue (*Festuca ovina*), Queen Anne's lace (*Daucus carota*) and smooth brome (*Bromus inermis*) with a mix of other grasses and forbs as described in Appendix 1. The sod-forming grasses were likely installed following the landfill closure as they provide soil stability and are somewhat drought tolerant. A mix of other grasses and forbs are present, providing a good variety, though again much of the species composition is non-native.

Photo 2: Upland Grassland view looking east from summit

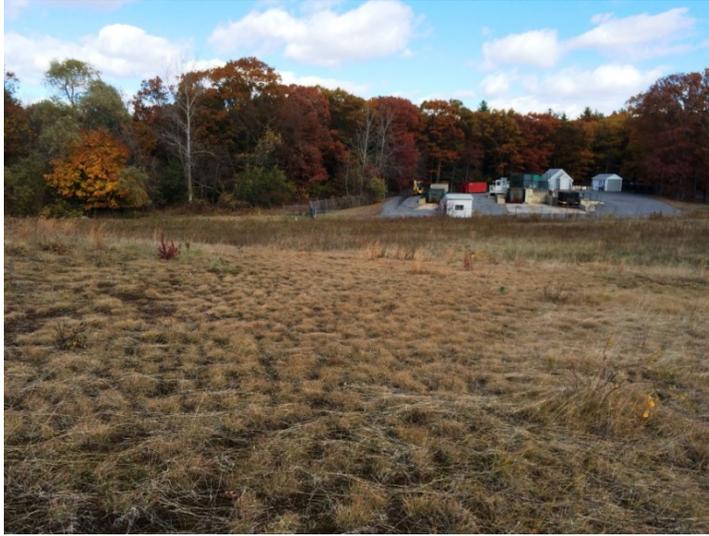
2. Bluestem/Moss Area: Approximately 0.5 acres on the eastern slope consists of very shallow and sandy areas with less dense vegetative cover. The area contains upland mosses and little bluestem, which are typical tolerant species and could provide evidence of a small fire in this area. Other species include mouse-eared chickweed, English plantain, red clover and goldenrods which occur throughout the site.

Photo 3: Bluestem/Moss Area view looking northeast

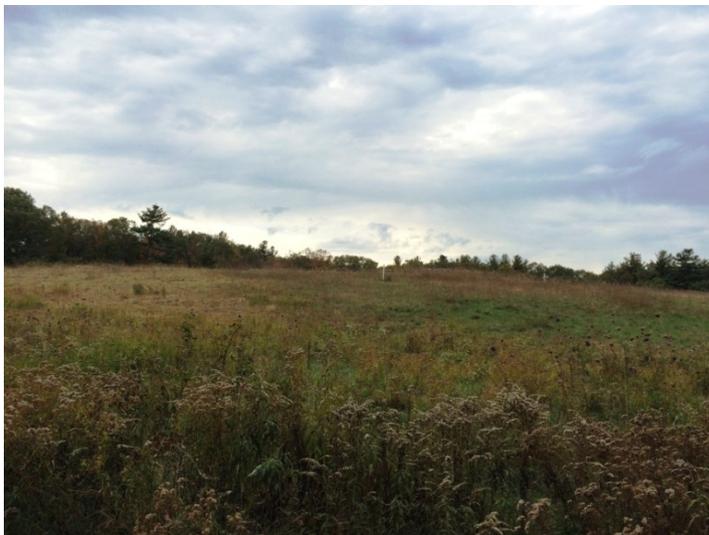
3. Goldenrod Pasture: This 1.2 acre habitat is located primarily along the lower slopes between the bluestem/moss area and the wet meadow described below. Its lower position in the landscape provides wetter soil conditions allowing for a greater diversity and density of plant species. It is dominated by goldenrods, but also contains other wildflowers such as queen anne's lace, aster, tansy and milkweed. Some woody stemmed vegetation, including glossy buckthorn, multiflora rose, lowbush blueberry and crabapple seedlings were also noted in this sub-community.

Photo 4: Goldenrod Pasture, view looking southeast

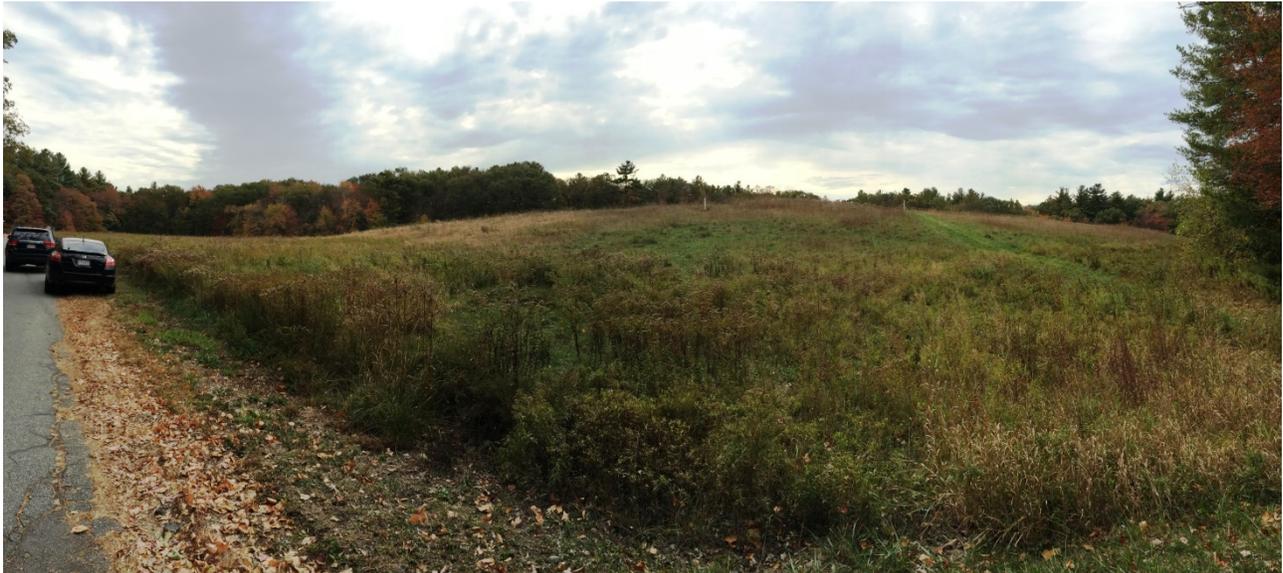
4. Wet Meadow: This small area includes approximately .09 acres along the base of the north and east slopes where drainage from the landfill mound collects near the access road. It is dominated by reed canary grass, purple loosestrife, goldenrods, sedges and rushes, pussy willow, timothy grass, foxtail grass and woolgrass.

Photo 5: Wet Meadow View from Access Drive

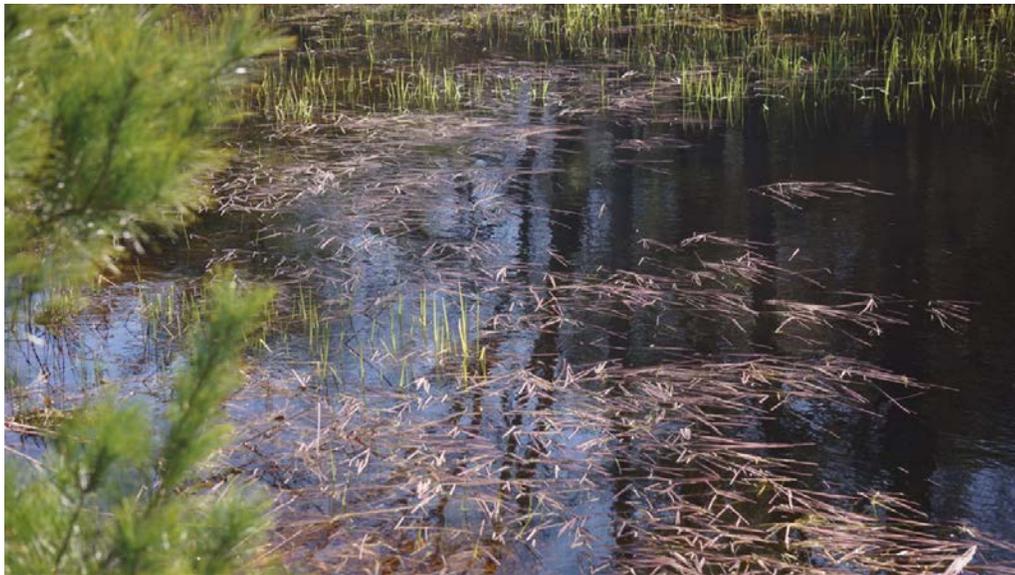
Photo 7: Vernal pool as viewed from southern slope of landfill

4. There is a vernal pool within the wetland located immediately to the south of the landfill. Cutting of trees in the vicinity of a vernal pool can affect potential migratory routes and overwintering sites for vernal pool species. The landfill site itself does not provide important contributing habitat to the vernal pool.

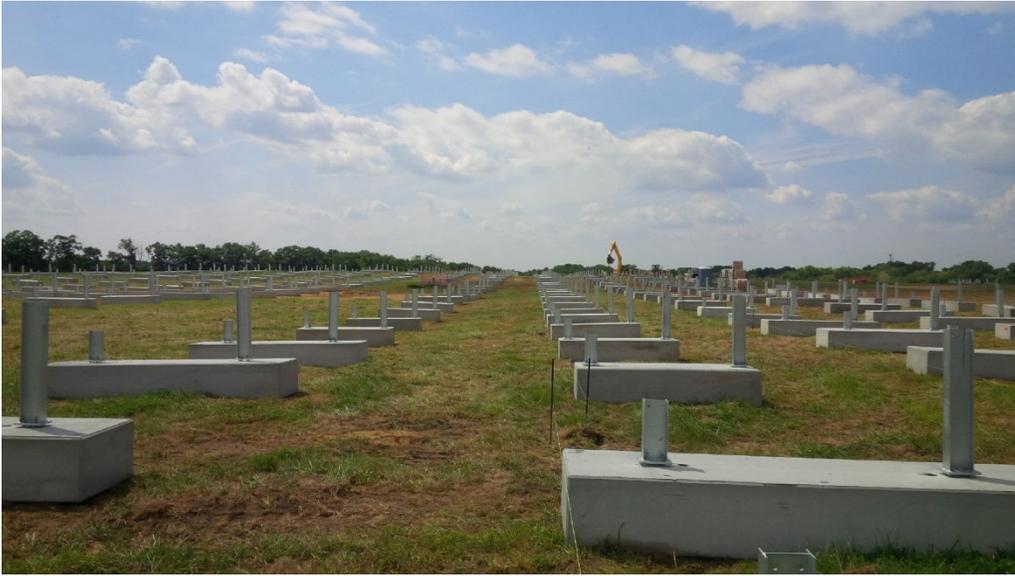
Photo 13: Ballast Installation, Parklands Landfill, NJ
Approx. 40 acres, 10 mW facility (Photo courtesy of Waste Mangement)

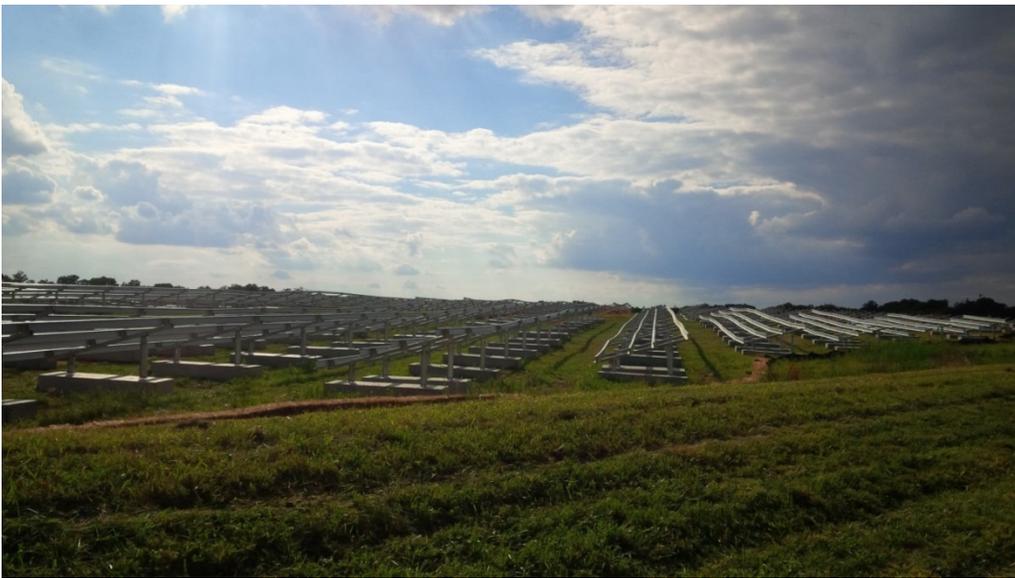
Photo 14: Racking System installation, Parklands Landfill, NJ. Note concrete ballast
(Photo courtesy of Waste Management)

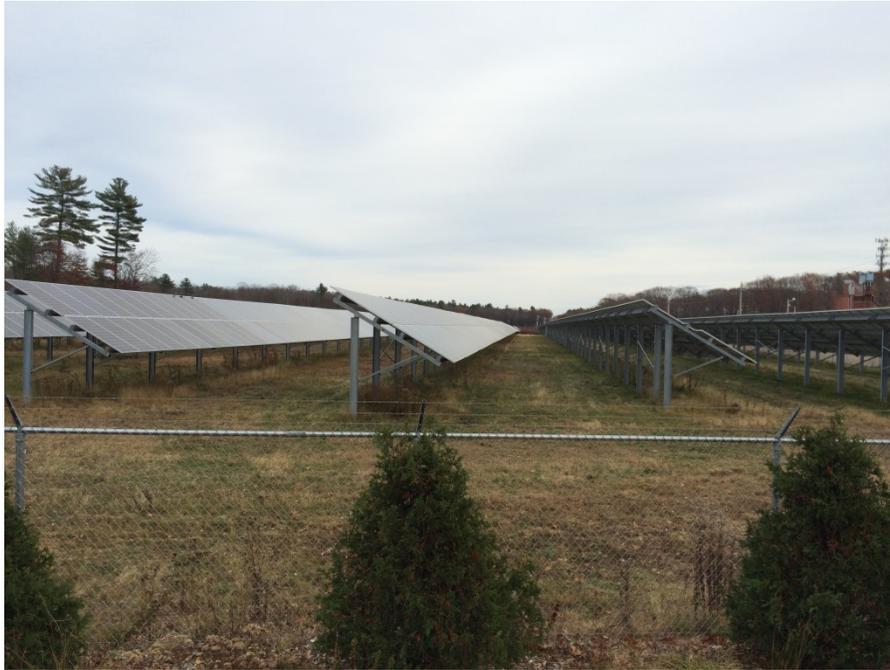
Photo 15: True North Energy, Salisbury, MA largest solar park in New England at time of construction in 2012.
Installation is 5.7 mW and includes 50 acres
